Fiber Wrap™

Innovative Solutions, Exceptional Performance

Application

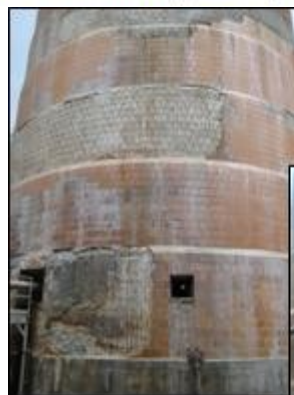
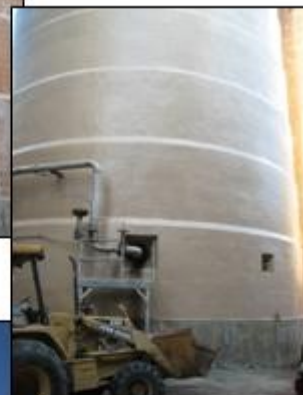
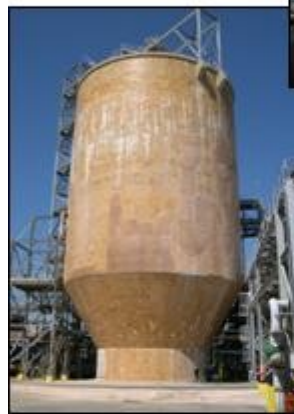
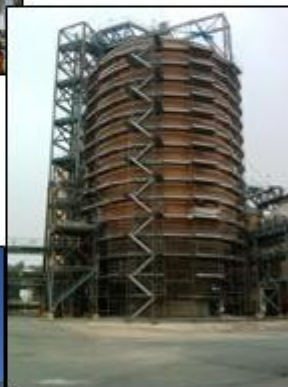
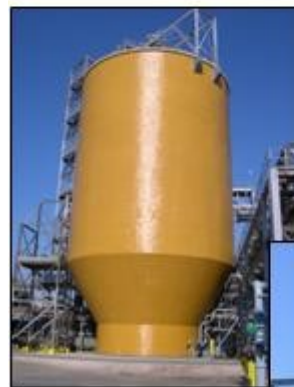
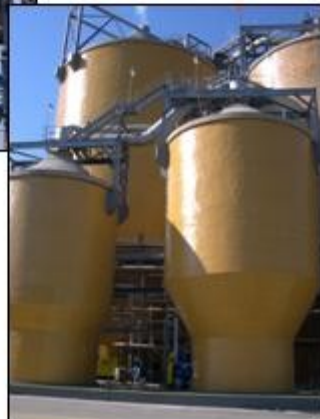
The ceramic glazed tile on tank exteriors becomes detached from the concrete wall. This is caused by repeated freeze-thaw cycles over time. Not only is this an aesthetic issue, but also a safety concern to both people and equipment below.

CoroTech's highly skilled team first removes all the loose material and sandblasts the exterior of vessel. Areas where tile are missing are plastered to the original profile. The reinforced epoxy system is then applied to the exterior surfaces. Finally, a urethane based top coat tinted to the customer's specifications is applied.

CoroTech's team of lamination experts applied the Fiber Wrap system to existing tile tank exteriors in a faster, higher quality, and more cost-effective manner. The vessels no longer pose a safety concern, and with customer specific color selection, the vessels blend visually with the other vessels in the area.
